EXPERT REPORT

Republic Services of Indiana, Limited Partnership

Coe Heating & Air Conditioning, et al.

Case No. 1:21-CV-00108

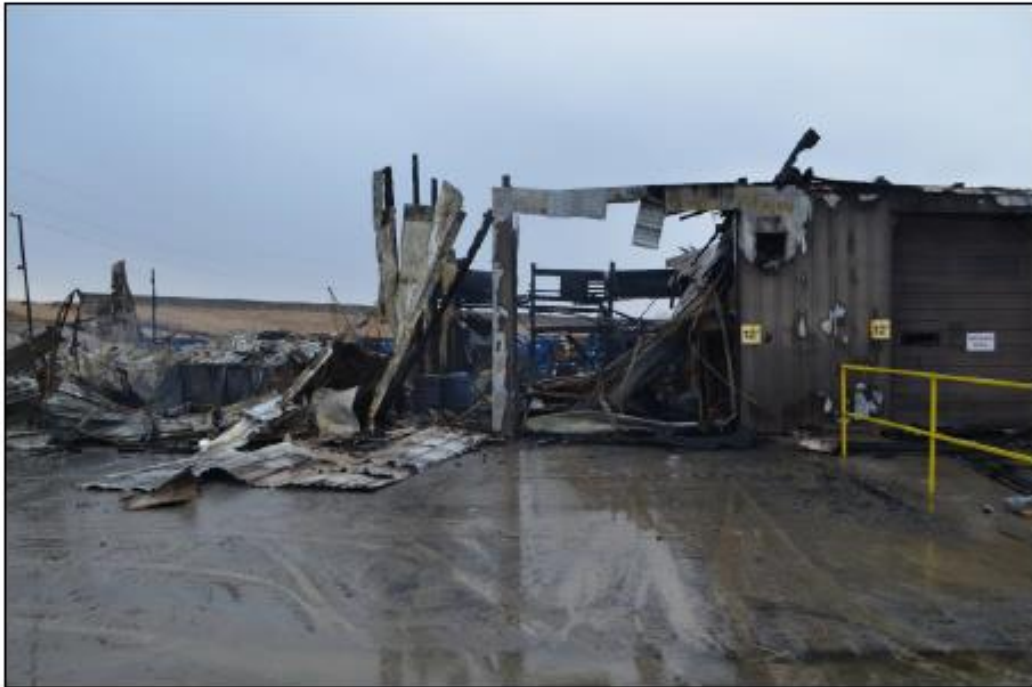
Photograph 1

East end of building at location identified as the paint room.

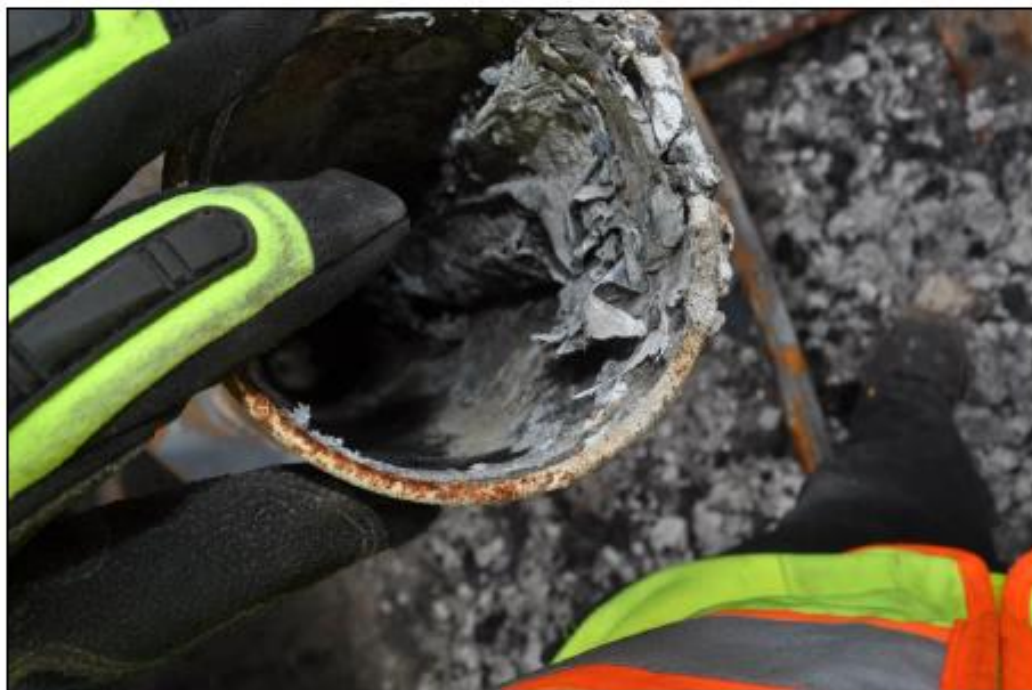
Photograph 2

Paint and other combustibles material inside ventilation pipe of tube system

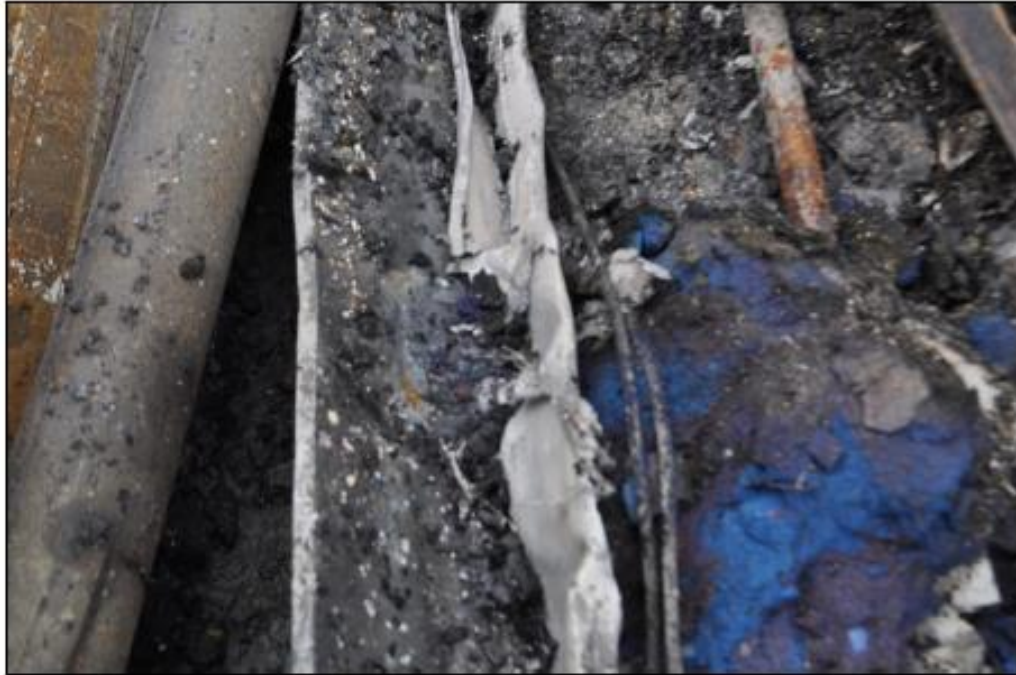
Photograph 3

Tube heater components and paint on reflector of unit, In area of fire origin.

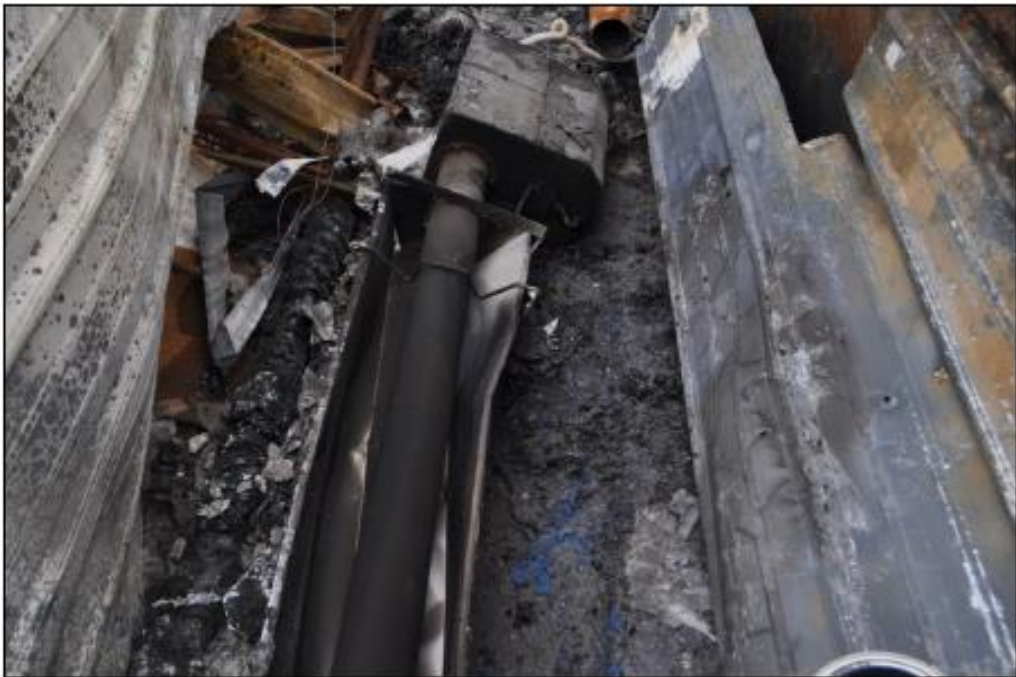
Photograph 4

Tube heater and paint on reflector along with charring and more heat on this heater unit than others. Indication origin area.

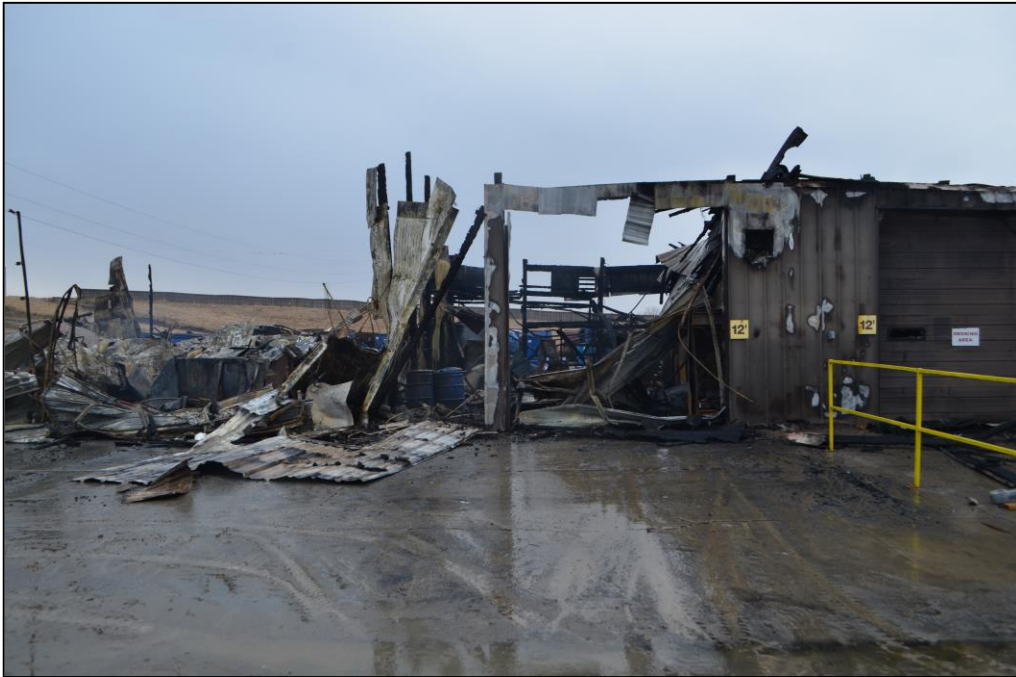
Photograph 1

East end of building at location identified as the paint room.

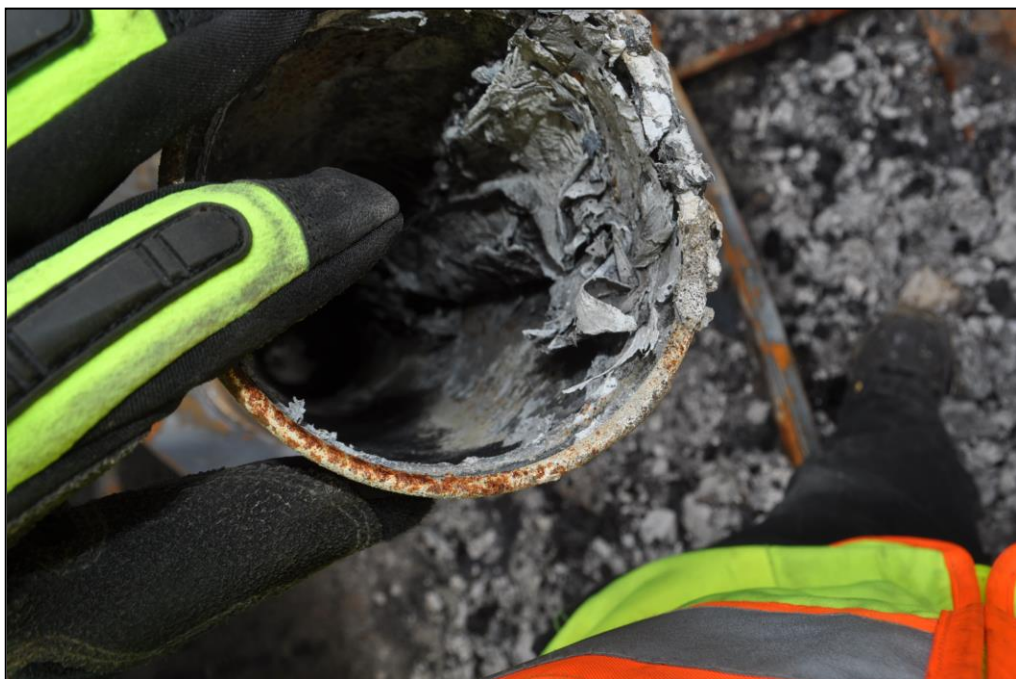
Photograph 2

Paint and other combustibles material inside ventilation pipe of tube system

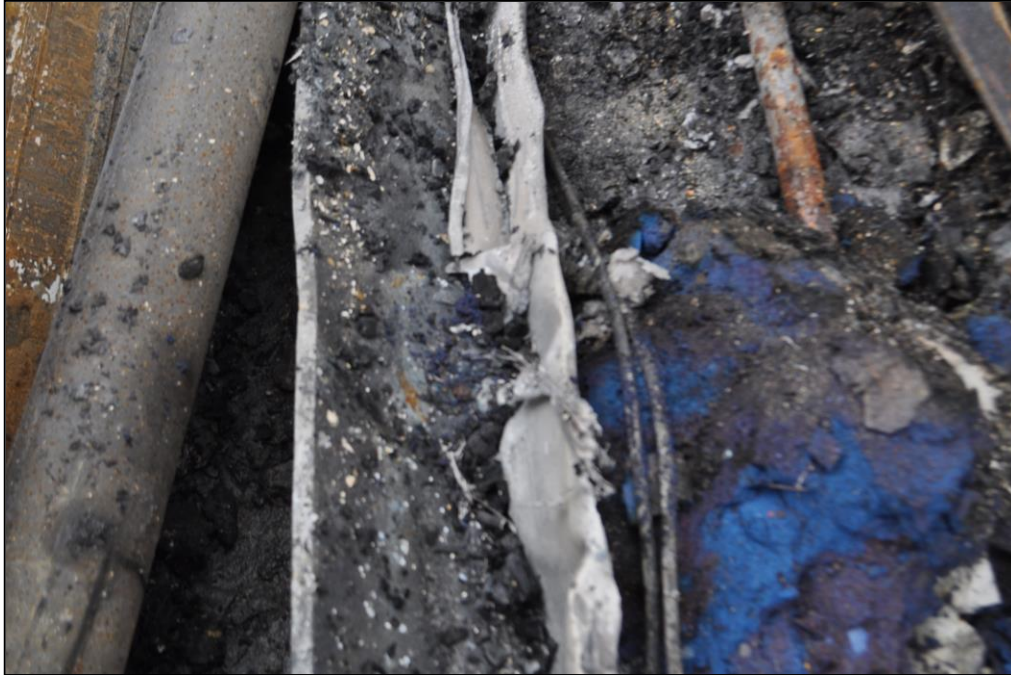
Photograph 3

Tube heater components and paint on reflector of unit, In area of fire origin.

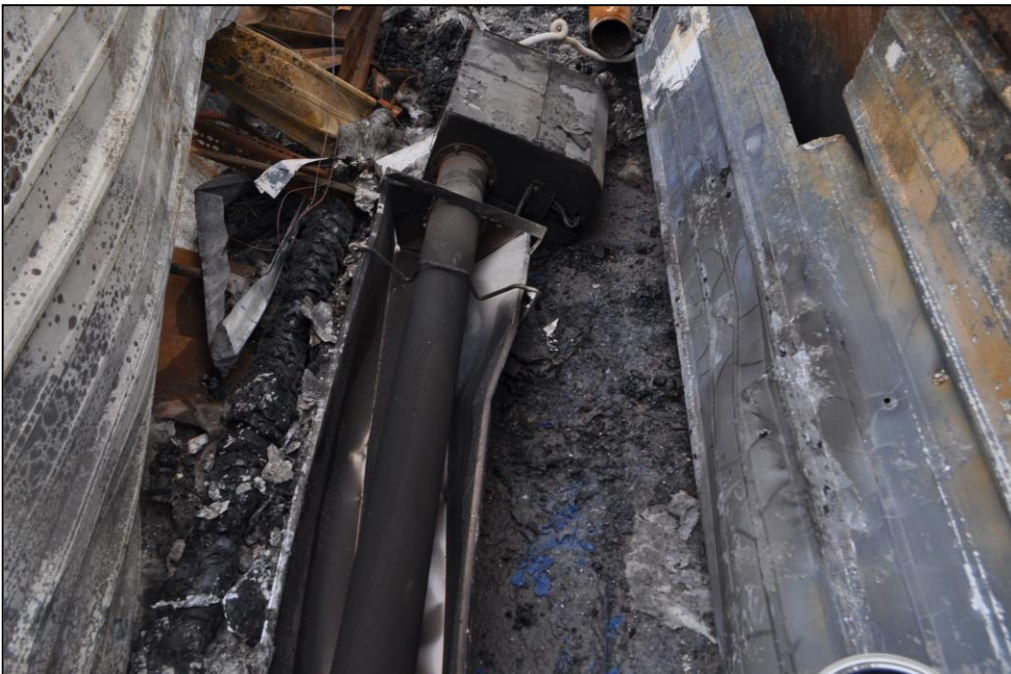
Photograph 4

Tube heater and paint on reflector along with charring and more heat on this heater unit than others. Indication origin area.

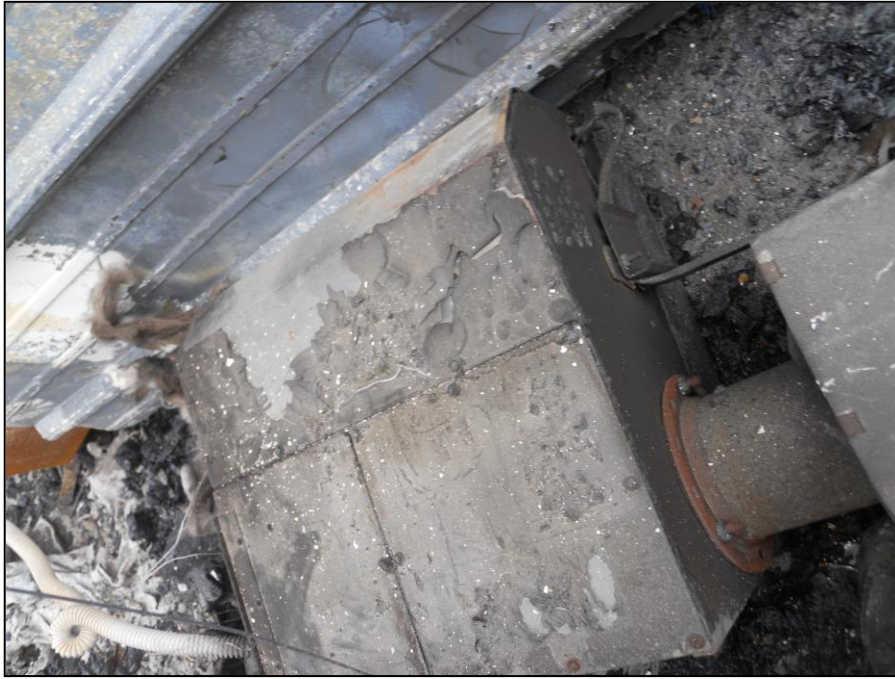
Photograph 5

Paint on reflector of another tube heater assembly.

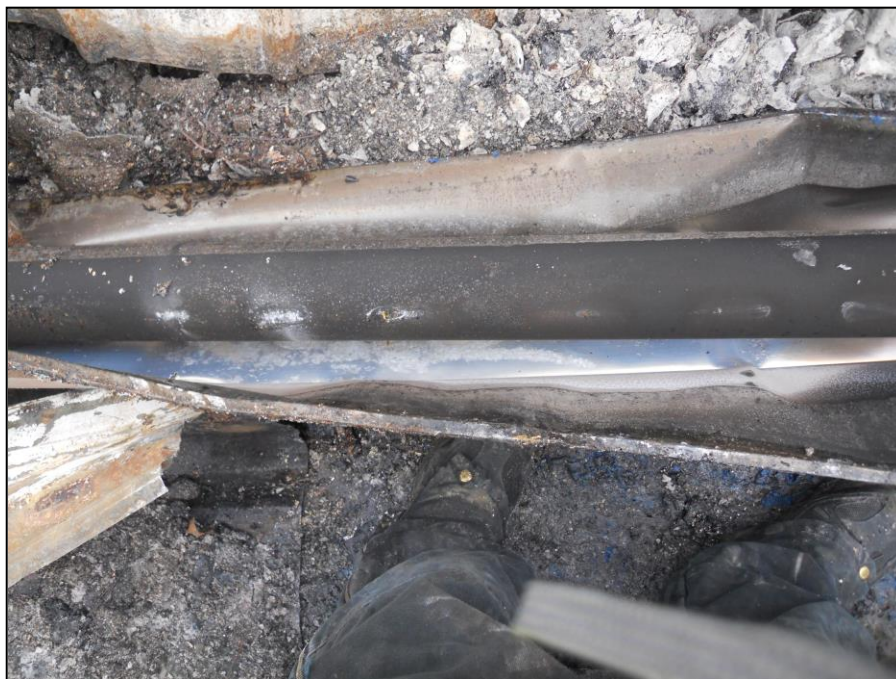
Photograph 6

Paint and other products on tube heater components in another location.

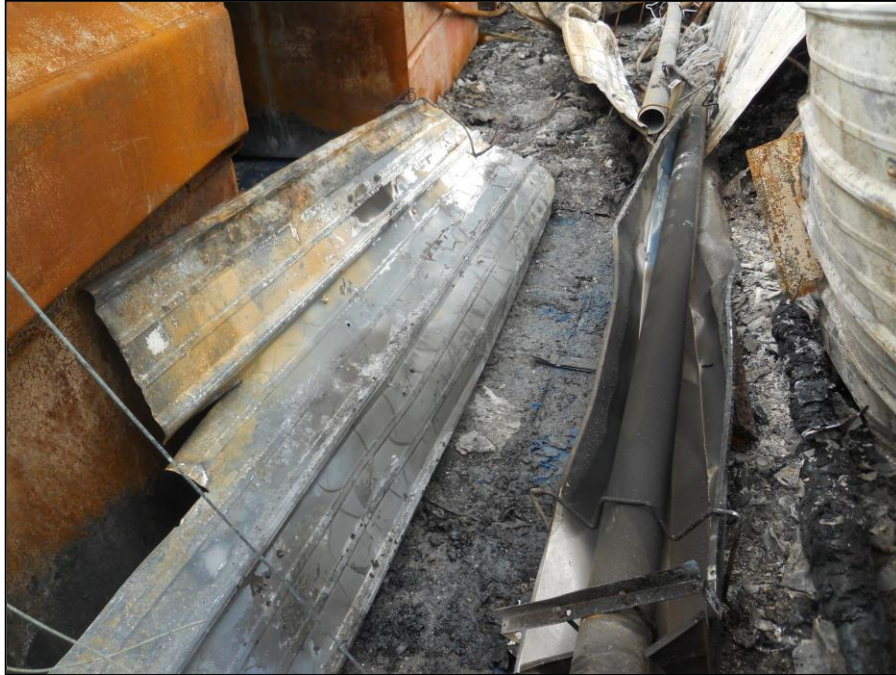
Photograph 7

Paint and charring on tube heater assembly in area of fire origin.

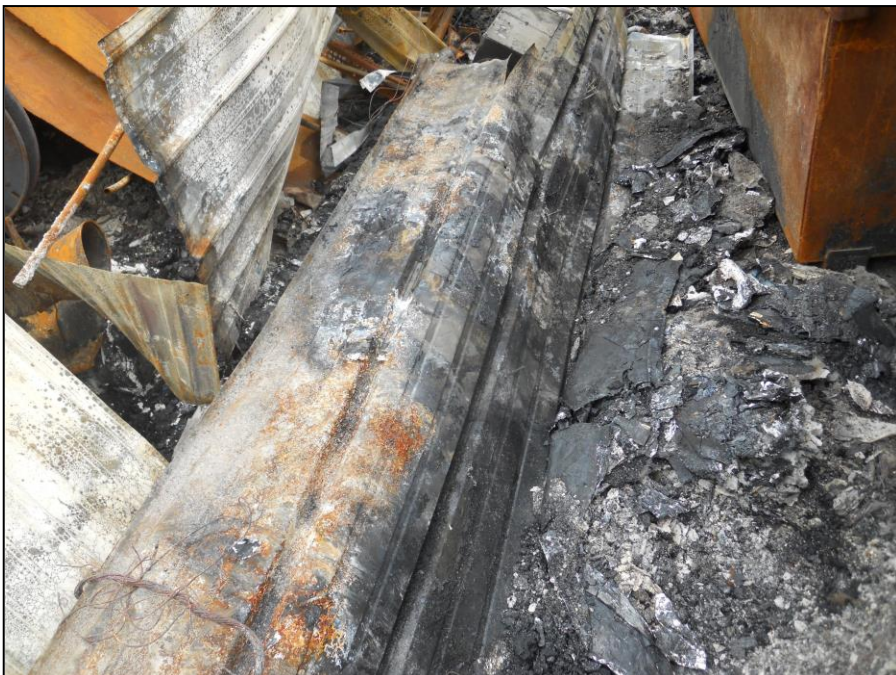
Photograph 8

Tube heater reflector top side and damage observed in area of fire origin.
